Supply, design and installation of mechanical input and extract ventilation systems.

CASE STUDY

Following the discovery of combustion issues with the heating boilers, Midtherm Engineering were asked to assess the suitability of the existing flue and ventilation systems on site at Wolverhampton Magistrates Court.

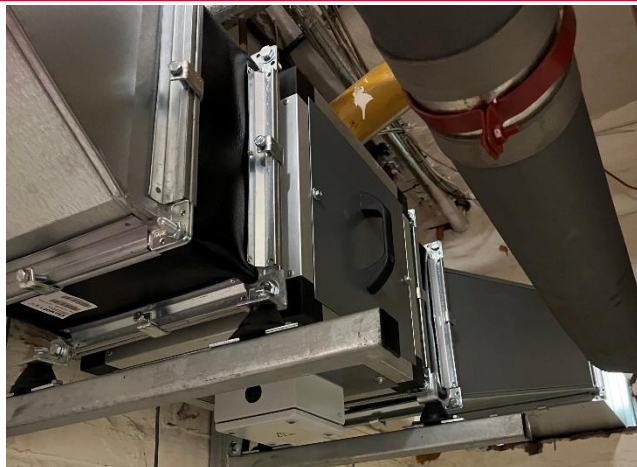
The boiler room was served by mechanical input and extract ventilation. The supply fan had failed several times, and the motor had been replaced recently, but issues remained with combustion. The route for the mechanical input duct was arduous to say the least, and it was also noted that a branch had been retrospectively fitted to the positive side of the ductwork to feed air to an adjacent plantroom. Calculations proved that the fan was incapable of delivering the required airflow volume against the resistance caused by the length, cross-section and route of the ductwork. This, coupled with excessive (relative to the amount of supply air) extract ventilation was leading to a noticeable depressurisation of the boiler room, starving the boilers of the required air for combustion.

Boiler room extract ventilation fan

With the root cause of the combustion issues being identified, we were then tasked with putting forward a proposal for a safe and compliant installation, as well as incorporating some additional background ventilation to two additional rooms.

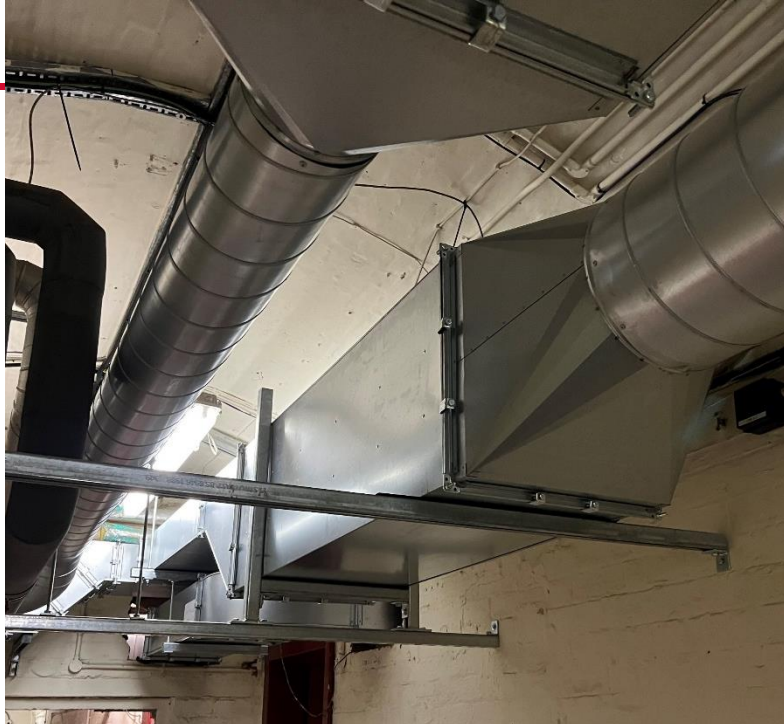
Noise is a critical consideration in a building of this type, particularly as the ventilation ducts would follow a route where court rooms are located above them. Having selected the most efficient, quiet and economical fans for the individual duties, we then worked with our acoustic partner to select attenuators giving the best balance between sound reduction and reducing the impact on fan duties.

Specialist attenuation installed within our ventilation ductwork.

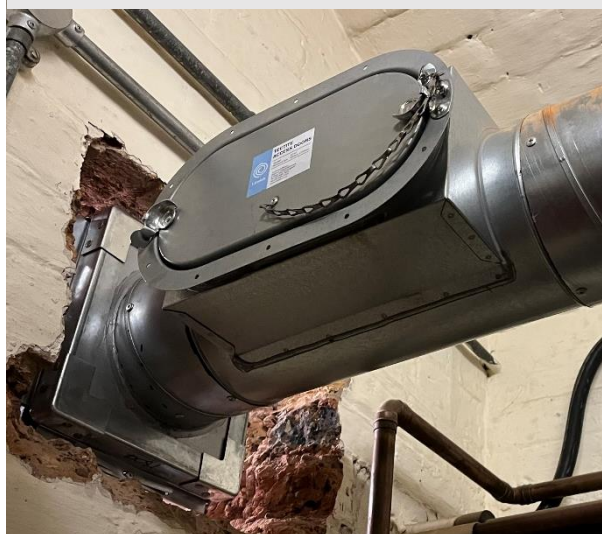
The duct runs crossed several fire break walls which necessitated the inclusion of fire dampers at each of these points, along with the necessary access doors to allow testing and inspection. As these fire dampers were a new addition to the building, careful consideration had to be given to both avoiding existing services and meeting the exacting requirements of the fire damper manufacturer's installation instructions and certification. This was managed with minimal impact on existing services through close coordination with the client's builder.

Fire damper and access hatch installed within a fire break wall.
