Supply, design and installation of new flue and reinstatement of existing fan

CASE STUDY

Braintree Community Hospital opened in April 2010. Located in Essex, the hospital provides inpatient and outpatient services including day surgery to the local community.

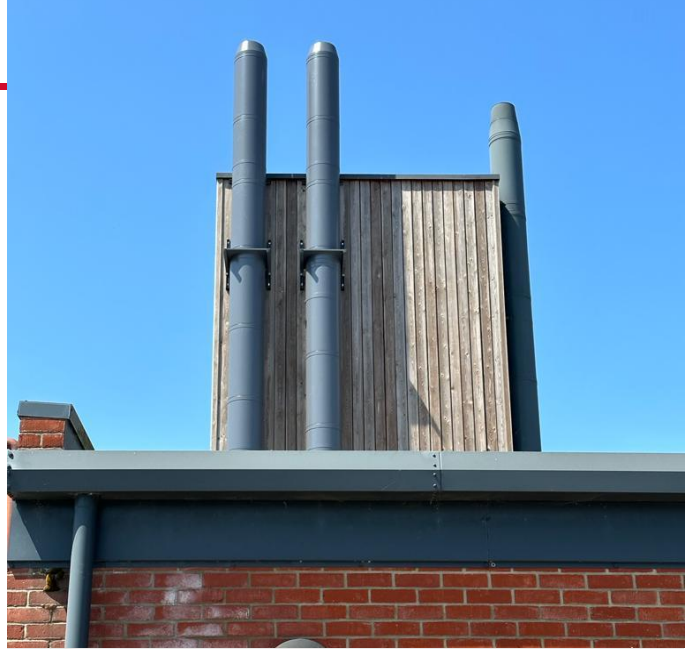
Flue systems powder coated externally to match existing building aesthetics

A plan was devised to install a new flue which would connect to one of the three boilers, allowing it to be functioning whilst the existing external flue was removed, the fan repositioned, and a new flue installed from the fan to termination.
